A STUDY ON THE WIND RESISTING CAPACITY OF TRADITIONAL ROOFING SYSTEM

Tshering Dema¹, Tshering Pema Dekar², Yeshe Dorji³, Tshewang Nidup⁴

Research and Publication Board, College of Science and Technology.

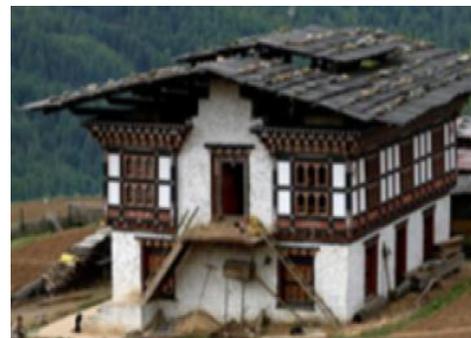
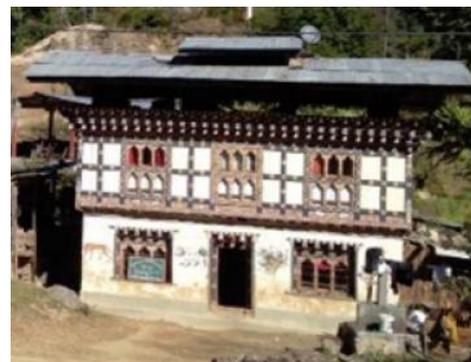
Fig.1 Transition from Shingles to CGI Sheeting

With the arrival of the modern construction materials, the traditional wooden shingles are gradually replaced with light corrugated galvanized iron (CGI) sheets and other similar materials. These material are considered to be more durable and convenient to work with requiring minimal maintenance.

The replacement of the traditional wooden shingles and stone boulders by modern light corrugated galvanized iron (CGI) sheets appears to have aggravated to problem further for the traditional roofing.

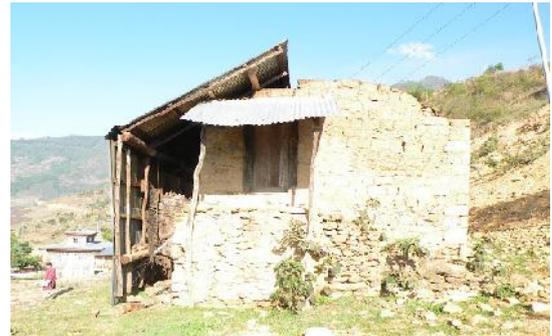
Fig.4 Wind damaged roofs(2011)

Bhutan has witnessed violent weather conditions in the recent years. One such event is the windstorm. Recently, windstorm has become one of the most frequently occurring natural phenomena in our country, destroying lives and properties each year (Lotay, 2015). Roofs of traditional buildings are often the most and worst affected structure by the wind.

Case studies on few traditional roofs revealed that nails are randomly used to secure connection between the various roof truss members. It is observed that the trusses are simply placed onto the building structure with no proper anchorages.

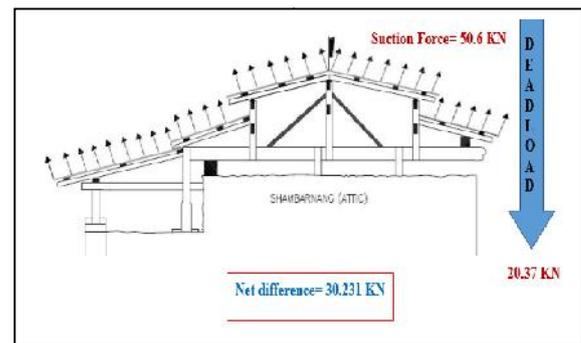
Fig. 7 Net force difference on a Drangim roof

Windloading analysis revealed that both the roofs experience a resultant net suction (uplift) pressure. Comparison between the total suction force acting on the roofs and the counteracting force (self weight/dead load) showed that the net suction (uplift) force is substantially large in both the roof types.

The dead load of the roof structure alone is not sufficient to hold the roof down whenever there is a strong wind. Moreover, the roof elements do not function as a single unit given the lack of their structural integrity because of poor connection and anchorages, making them more susceptible to damages.

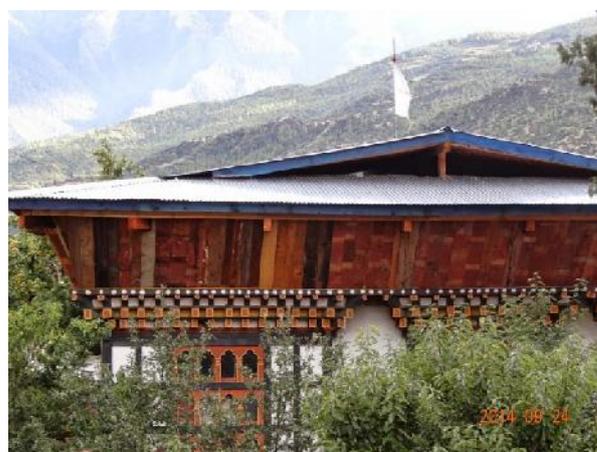
Fig.9 Enclosed Roof.

Closing of the openings can also be carried out to reduce the suction force coming on the roof.

In the present case study, however, even with the internal pressure coefficient (+/-0.2) for the least opening ratio of 5%, the net suction force on the roof was found still very substantial.

Further, complete closure may not be feasible since traditional architecture demands a small opening to be kept for the purpose of aeration of the timber members and for drying of the food grains, vegetables and hays.

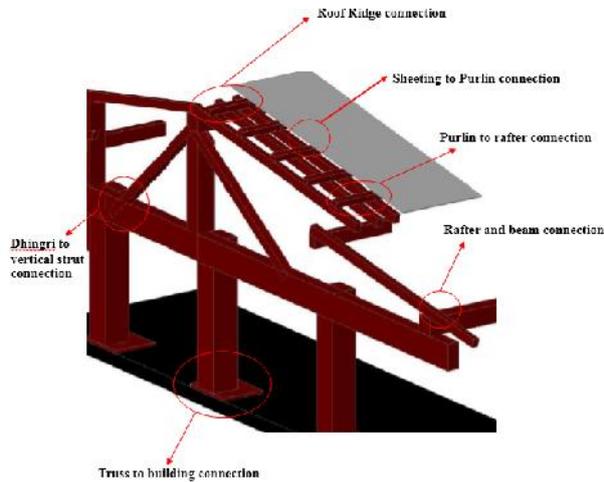
Fig. 10 Connection Points.

The structural integrity of the roof elements has to be improved for whole roof structure to behave as a single unit. This can be achieved by providing adequate connection between the various roof members. Most roof failures are observed along the connection between the members.

The connections that need to be secured are:

1. Roof ridge connection
2. Sheeting to purlin connection
3. Purlin to rafter connection
4. Rafter and beam(dhingri) connection
5. Dhingri to vertical struts connection
6. Truss to building connection

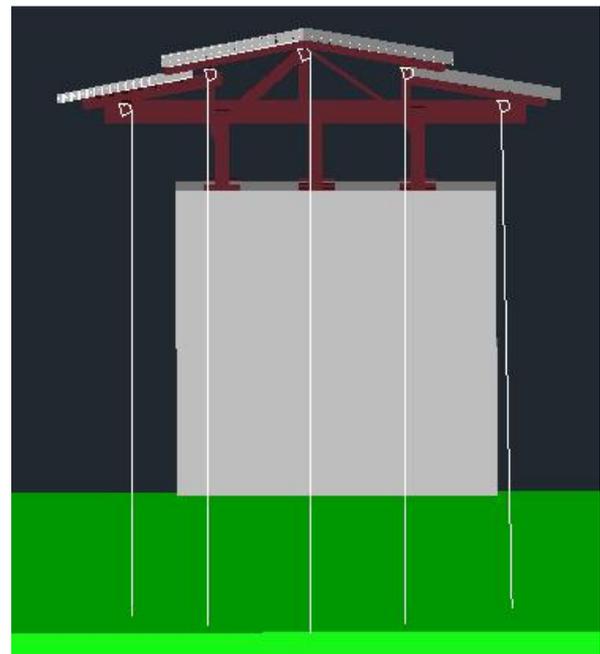
Fig.16 Tension Cable connection from the roof ridge

The anchorage of the whole truss to the building structure needs to be secured. It was observed that the most effective means to secure proper anchorage of the truss is to anchor the truss to the ground. This could be achieved via the use of tension cables.

Anchorage can be provided along the Dhingri member as the dhingris the most common roof feature in all the traditional roofs. After securing all the connections between the various roof elements, anchorage along the Dhingri can be provided.
